Land Subsidence in the Harquahala Valley, Maricopa County
Based on ADWR EnviSat Time-Series InSAR Data
Time Period of Analysis: 1.1 Years 01/25/2007 To 02/14/2008

01/25/2007 To 02/14/2008

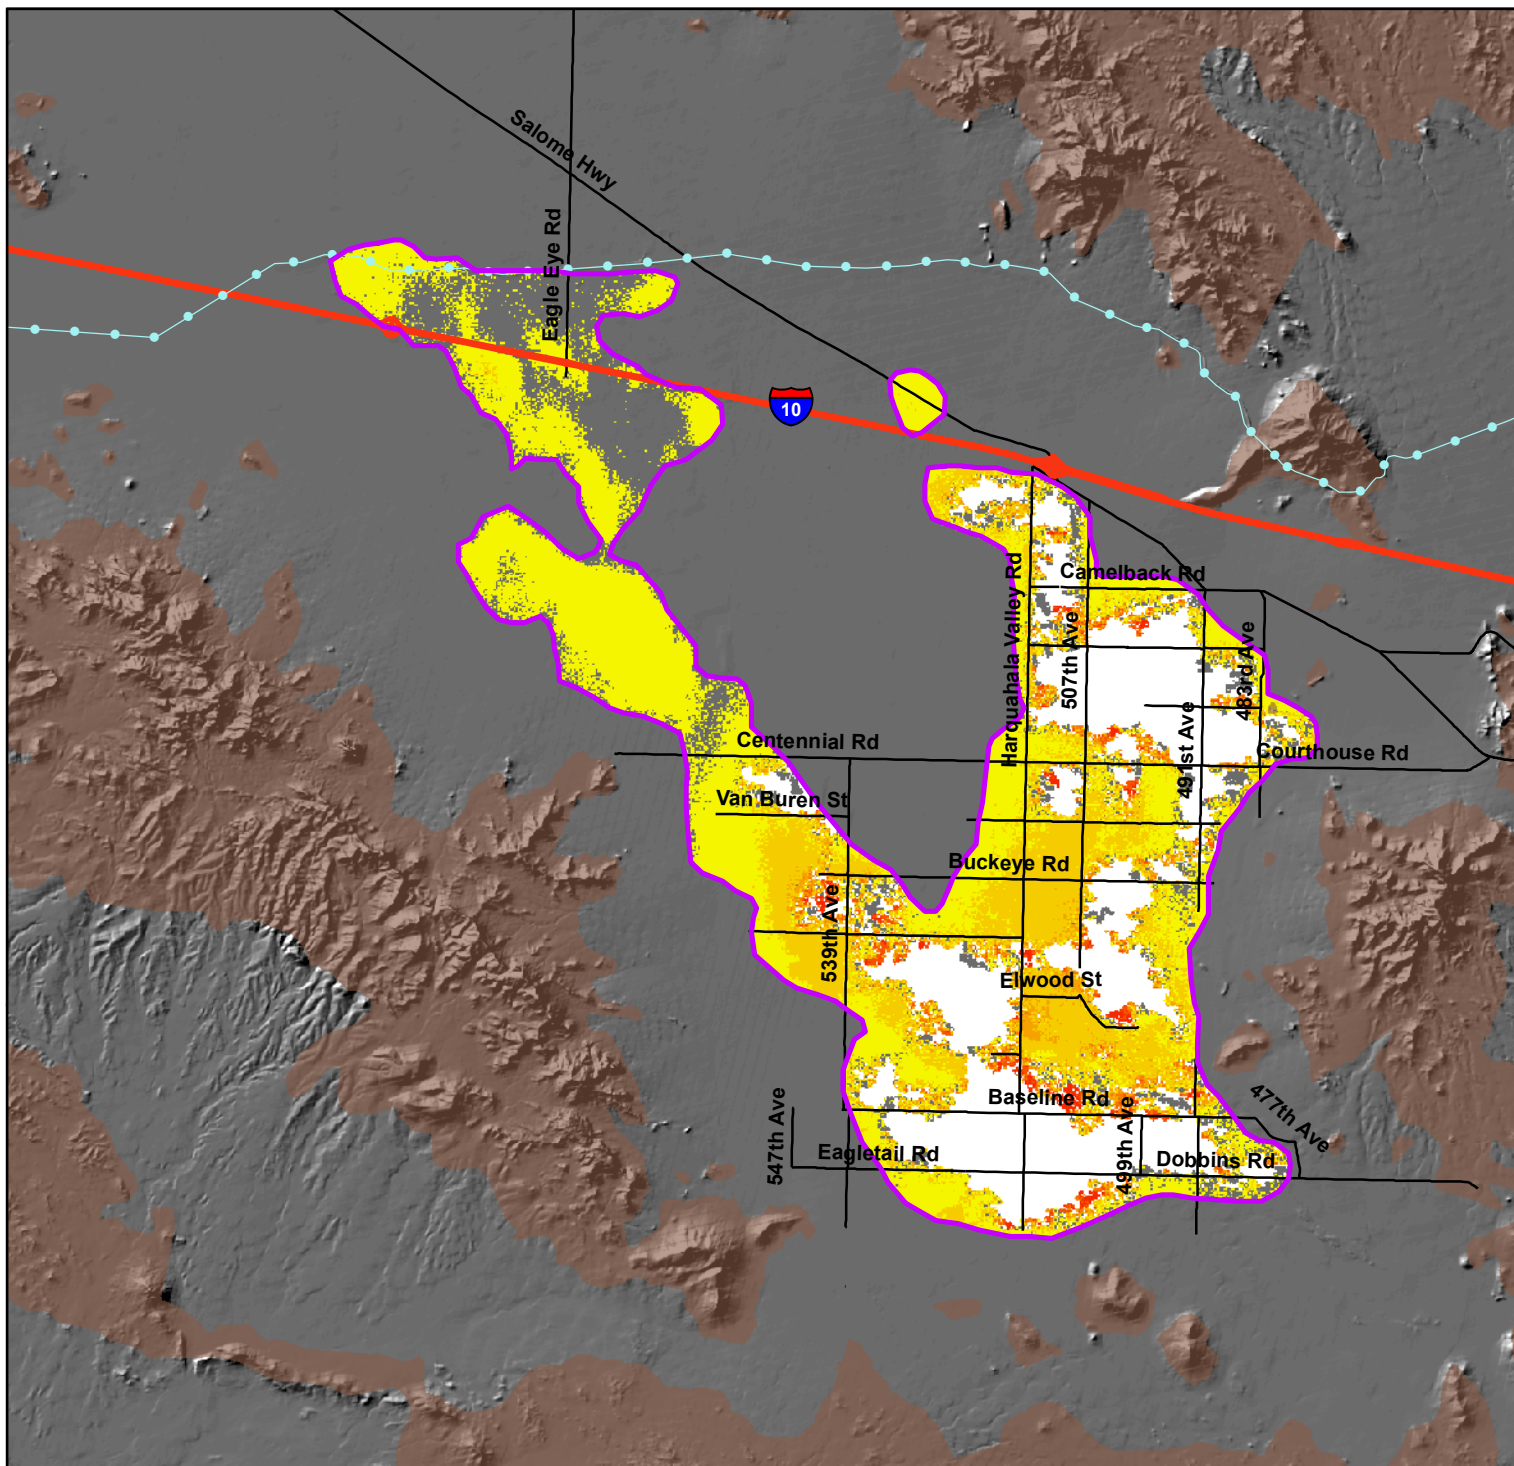
Decorrelation (white areas) are areas where the phase of the received satellite signal changed between satellite passes, causing the data to be unusable. This occurs in areas where the land surface has been disturbed (i.e. bodies of water, snow, agriculture areas, areas of development, etc).
